**PACIFIC GAS AND ELECTRIC  
COMPANY'S RESPONSE TO  
REQUEST FOR INFORMATION**

# Electric Transmission Overhead Steel Structure Strategy Overview

## STRUCTURES

**Prepared by: Quanta Technology  
May 2010**

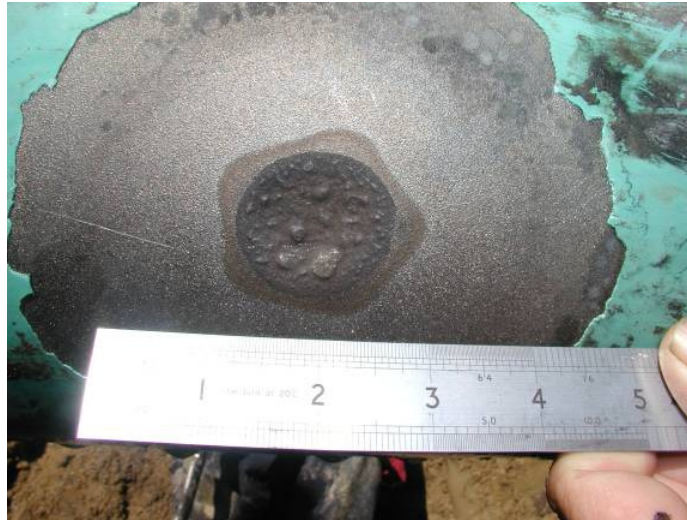
**Figure 4-4. Corrosion Cause by Stray A-C**

In recent years corrosion of carbon steel structures has been documented as a result of induced AC. Corrosion rates of 2.4 mm/yr (60 mpy) have been documented on pipelines with high quality dielectric coatings. Critical current densities of 100 amperes/m<sup>2</sup> are necessary for AC assisted

corrosion requiring pinhole defects in coatings to concentrate the current density. An example of the corrosion morphology associated with AC interference current is shown in Figure 4-4.

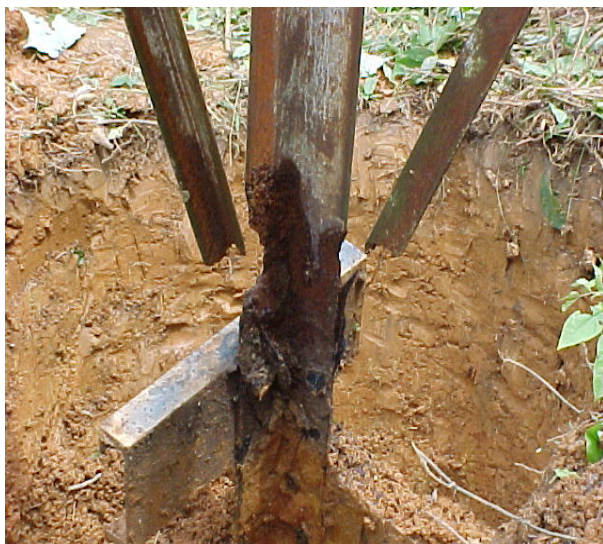
- 1) Atmospheric to below ground transition, and
- 2) Water table transition.

At the atmospheric to below ground transition, corrosion cells are established due to the abundant availability of oxygen and moisture in the transition between above and below grade.

Prevailing rains can concentrate atmospheric pollutants due to ponding of rainwater in this immediate region. This ponding establishes differing chemical environments in contact with the same structural member as well as establishes corrosion cells with adjacent tower legs.
